Rail Replacement at Bow December 2009 to February 2010

Dick Henrywood

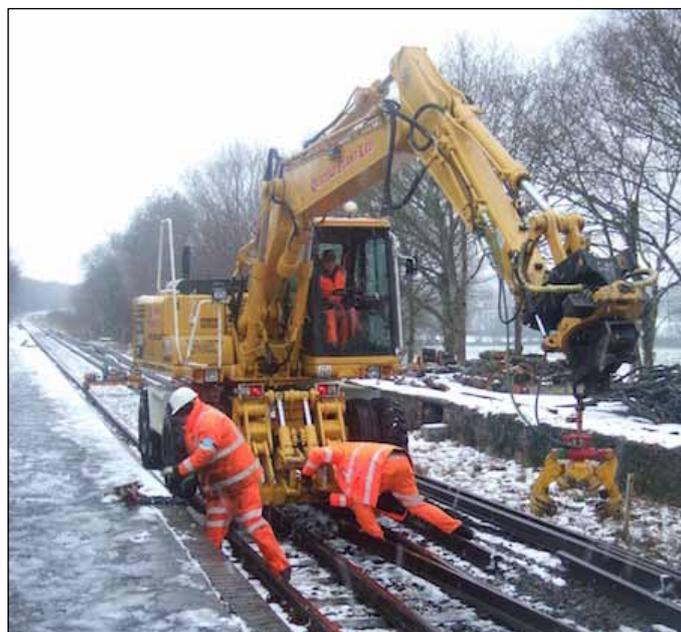
Figure 2. Positioning rail using one of the rail-mounted tractors on 12 January.

again in earnest on Monday 11th January. A gang of men arrived to start preparing the track lengths ready for installation but unfortunately their equipment didn't turn up so no work was done. The following day was a little better, despite the late arrival of equipment, and preparation of the rail got underway. This entailed cutting clean ends for each track length, making sure there were no welds close to the ends, and positioning the prepared lengths right alongside the existing track. This entailed the use of an interesting rail mounted tractor-come-crane, two of which were to become regulator workhorses over the next three or four weeks.

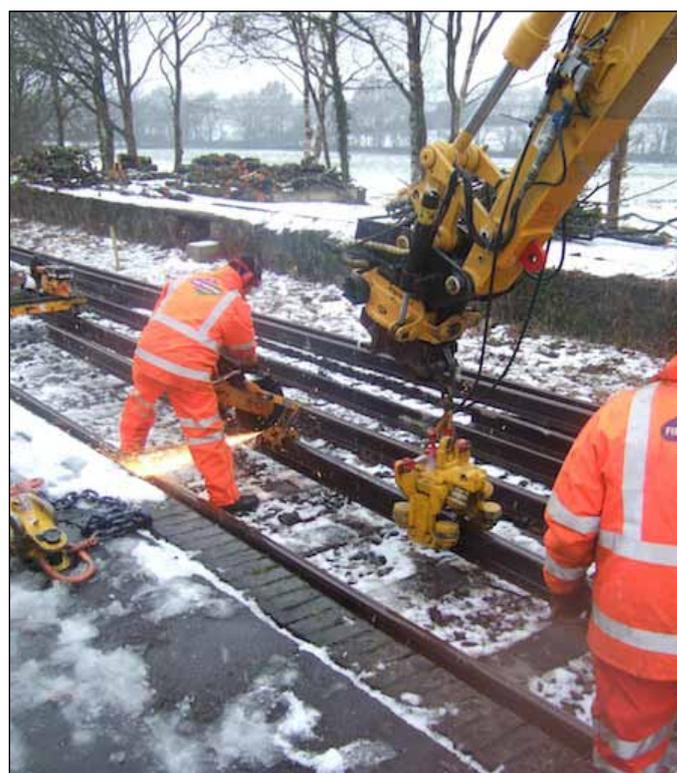
Figure 3. Cutting rail ends on 12 January; notice the rotten weather.

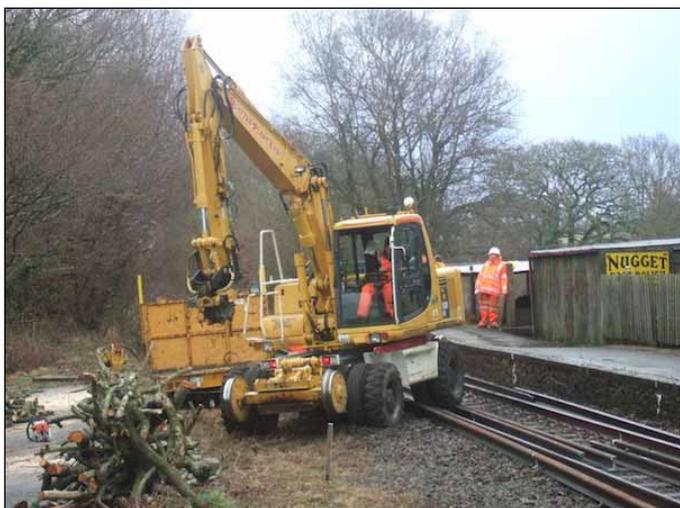
Figure 4. Rail-tractor moves out of the way ready for arrival of the Tamper on 15 January.

then on Friday 15th January a delivery of sleepers passed by on its way to Meldon early in the morning double-headed by Freightliner 66 604 and 66 624. They returned light engines mid-morning and rail work was also interrupted by the Tamper which passed by at lunchtime. Early evening saw the arrival of the High Output Track Replacement train (HOTR), sighted for the first time of many as it headed to be stabled at Meldon. A busy day.

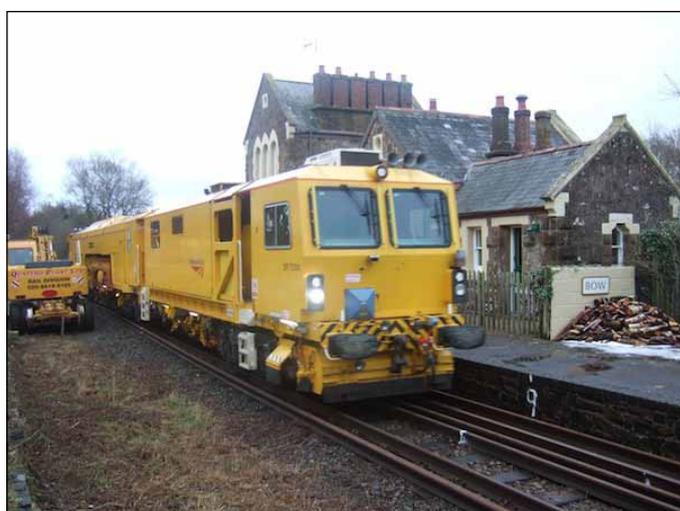
Figure 6. The Tamper passes Bow Station on its way to be stabled at Meldon Quarry on 15 January.

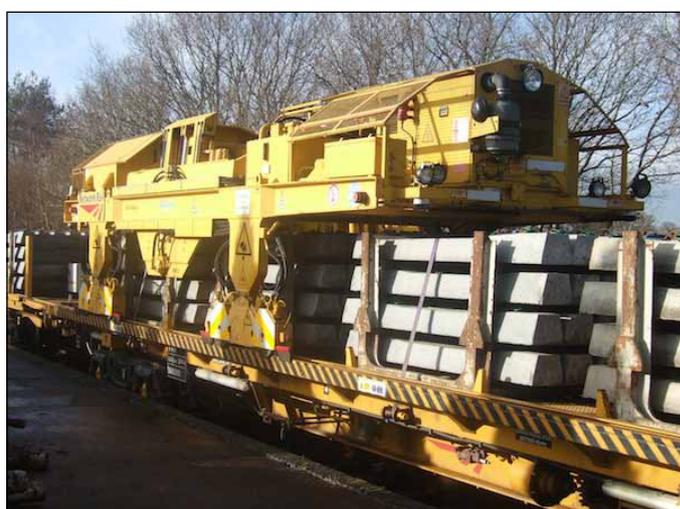
Figure 8. New concrete sleepers on the HOTR train alongside Bow Station on 16 January.

Work started in earnest the following day with the first use of the HOTR train delivered by Freightliner 66 624. It started work midway between Buttisland Crossing and Bow Station, working up towards Bow, and spent over seven hours on site. It was followed by a set of five ballast wagons hauled by 66 604. Initially, one of the most impressive parts of the operation centred around the onboard cranes which run up and down the HOTR getting the new sleepers in place and removing the old sleepers to be taken away.

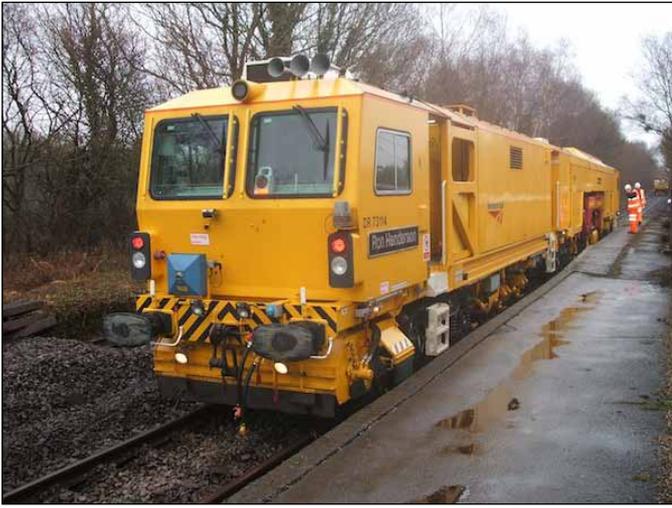
Figure 9. The Tamper unit at work, DR73114 “Ron Henderson”

Sunday 17th January saw the first run of the Tamper, DR73114 "Ron Henderson", which slewed the old track away from the platform at Bow to provide clearance for the HOTR, which started work again mid-morning. This was one of the most in-

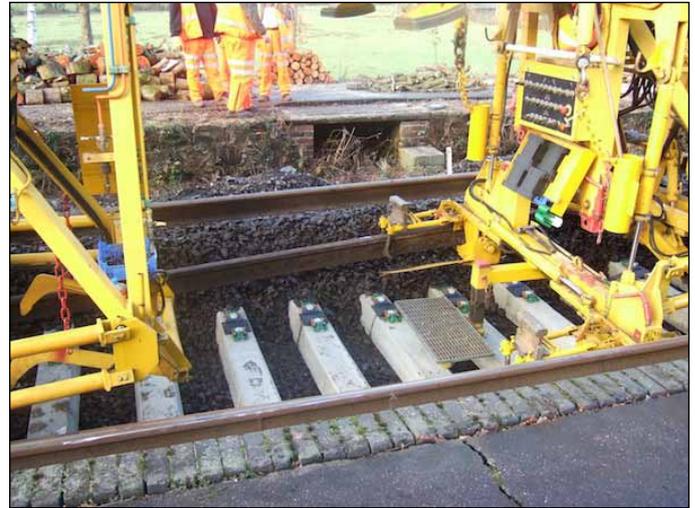
Figure 10. Replacement rail fed onto the newly-laid sleepers on 17 January.

teresting days with fantastic close-up views of the operation beneath the train as it lifted the old rail, removed the old sleepers, placed the new concrete sleepers and finally laid the new rail, all in one continuous operation – fantastic! Obviously it is impossible to show the work successfully in still images but the enthusiast can see the whole operation in some detail on the train manufacturer's website www.matisa.com (select "Track

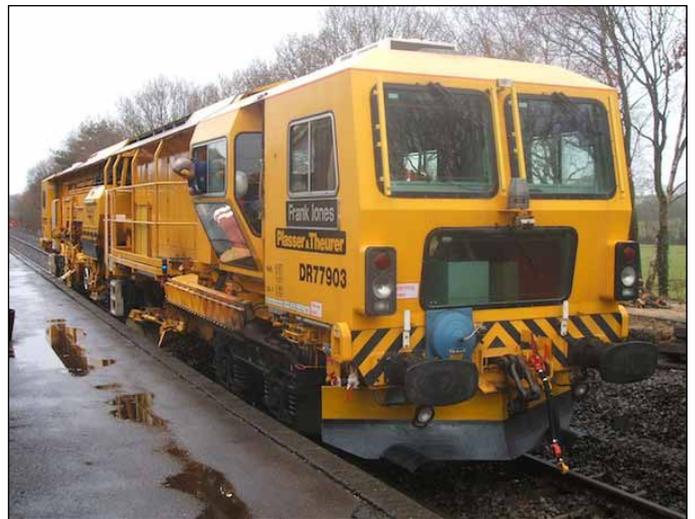
Figure 11. The Regulator DR77903 “Frank Jones” on 22 January.

The whole of the next fortnight was taken up with similar operation of the HOTR and the Tamper, with the first appearance of the Regulator DR77903 “Frank Jones” on Friday 22nd. This device follows the Tamper and effectively performs a clean-up operation, moving excess ballast to the sides of the track and sweeping up. The HOTR finally completed its work by Friday 29th, and departed the line at teatime, followed shortly afterwards by the Tamper, which was to return later.

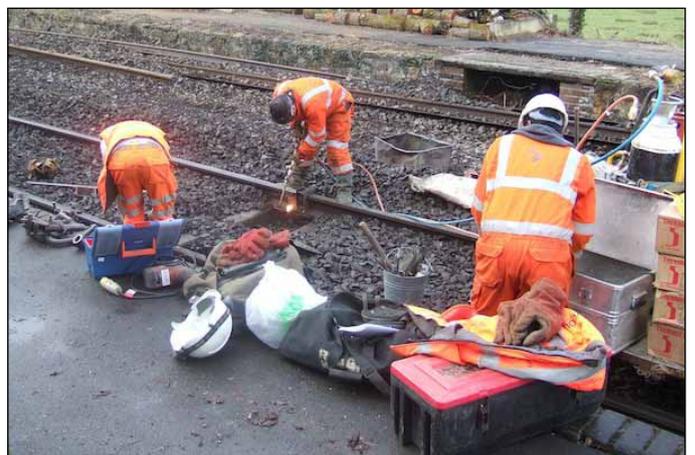
Figure 13. Preparing one of the rail joints for welding on 1 February.

The week beginning Monday 1st February saw the start of the final track operation, welding all the joints, fitting the breather slips (expansion joints) at each end of the continuous section, and tensioning the new length of track.

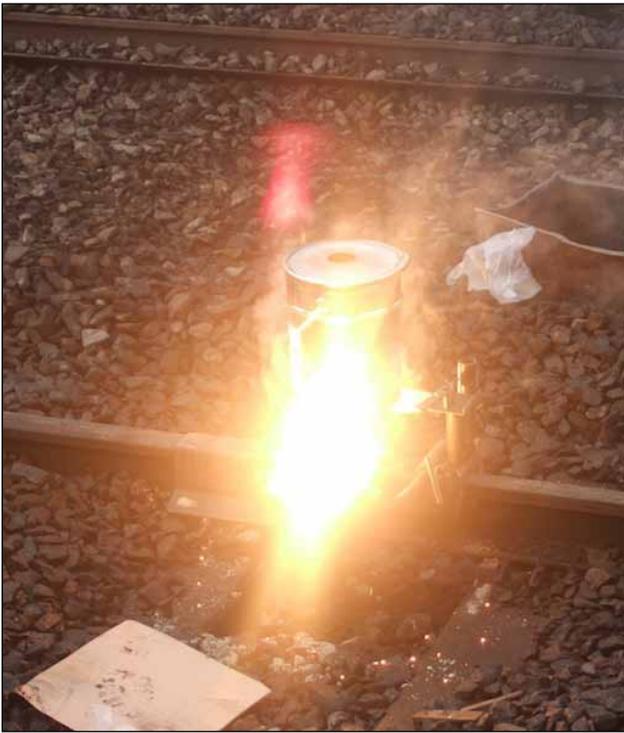
Figure 14. Thermite welding of the joint – fireworks at Bow!

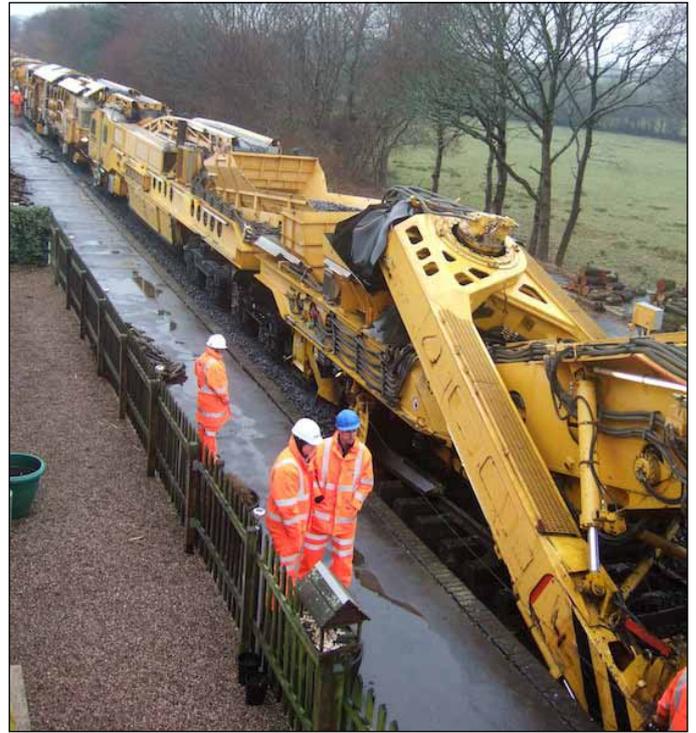
Figure 15. The main working section of the HOBC train, seen on 23 February.

The following week was dormant with little apparent work, albeit still with a number of hi-vis vests around, but the next operation was to start on Monday 22nd February. This was ballast cleaning with the automatic HOBC train. This device works slowly along the line, completely lifting the track and attached sleepers, clearing out all the existing ballast, sieving and sorting the ballast, feeding clean ballast back down onto the track bed, supplemented by brand new ballast where necessary, and relaying the track and sleepers. This all takes place in a central section of the train over a length of about 20 metres, the remainder of the very long unit having hopper wagons to take the reject ballast at the front, and further hopper wagons full of new ballast at the back, all joined by continuous belts.

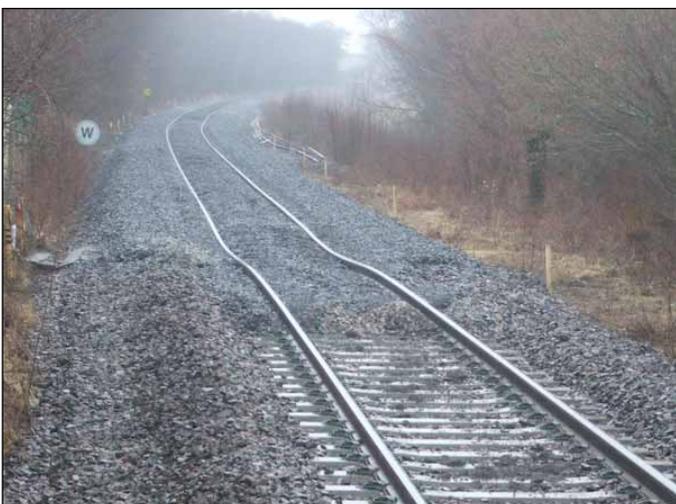
Figure 16. A minor hill in the track at the end of the day’s work on 23 February, before the HOBC restarted work.

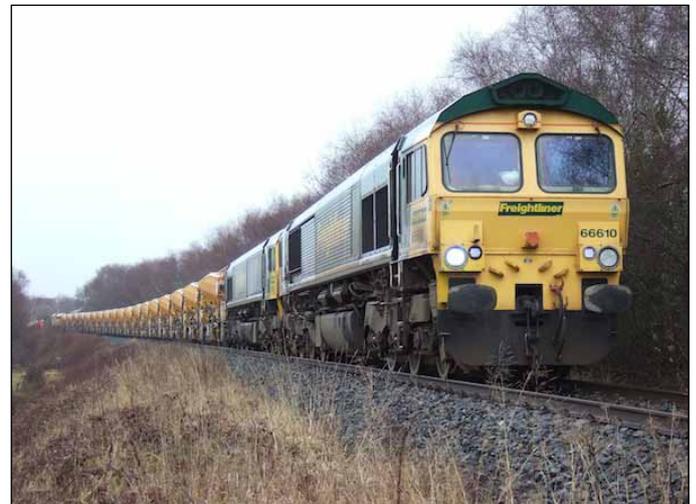
Figure 17. A record train? 6Y11 departs Bow for Meldon, this time on 25 February (courtesy Peter Chapman).

“Yesterday evening [22 February] Stuart Cowan and I believe that we worked the longest, heaviest, most powerful train ever on the line (unless anyone knows different?). 6Y11 was worked from Fairwater empty by Darren and Eddie in two halves as Network Rail wouldn’t allow it to run as one train. At Meldon it was loaded with stone and joined together, then worked to Bow with just 66 617 powering. After work had finished at Bow the train was worked away with 66 610 & 66 605 leading. The spoil was dropped on North Tawton Bank and restarted with all three locos powering for the run to Meldon.

Vital statistics of the train:

2934 tons, 2373ft (113SLU) 40 vehicles long, plus locos 66 610, 66 605, & 66 617, combined hp 9900, combined tractive effort 315,240lbs (1401kN).

Interestingly 610 & 605 in multiple handled the train with no problems, the addition of 617 made it pretty effortless”.
